**Second Five-Year Review Report  
for  
MGM Brakes Superfund Site  
Cloverdale, Sonoma County, California**

July 10, 2008

# Five-Year Review Report

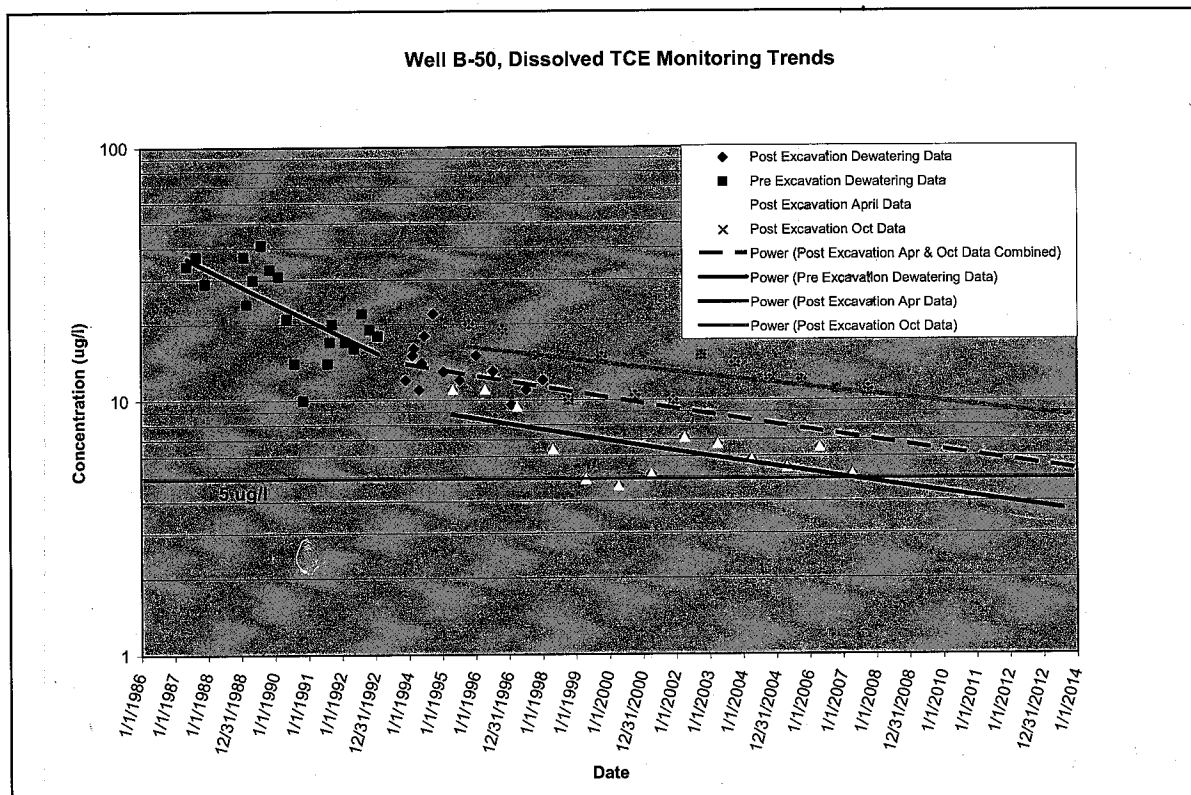
### **Figure 3**

averaged seasonal conditions, it is best to consider both seasonal high and low concentrations. Therefore the complete data set of spring and fall concentrations should be considered most appropriate. Extrapolation of the complete data set regression line suggests, barring atypically quicker natural attenuation, averaged TCE concentrations will not decline to below 5 µg/l at well B50 until sometime after January 2014 (See Figure 3).

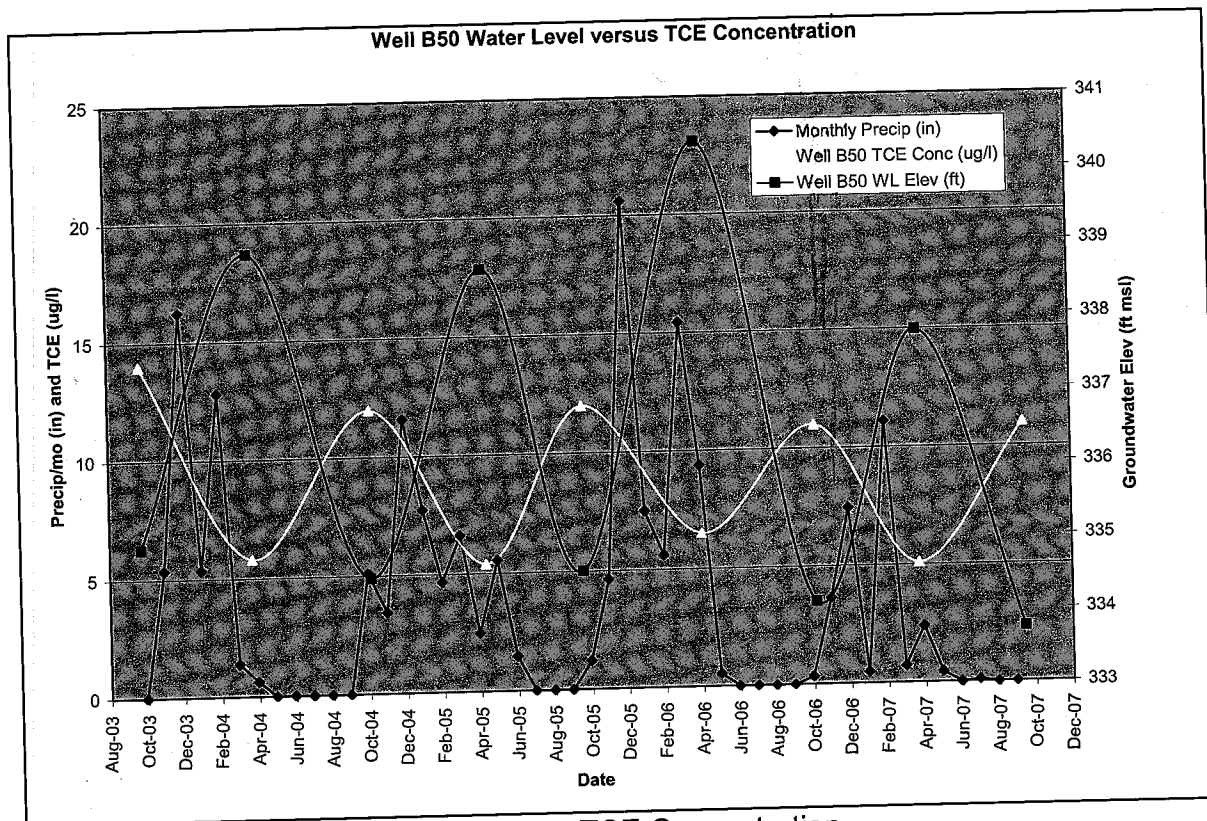
## **Figure 4**

The observed pattern of seasonal cyclical groundwater elevation changes (i.e., higher elevation in spring and lower elevation in fall) do appear to slightly influence contaminant concentrations. TCE dissolved in groundwater is consistently highest during the fall sampling event, when groundwater elevations are lowest. This relationship can be clearly seen in Figure 4. For this reason, the average TCE concentration is best depicted by taking an average of the spring and fall yearly events. For this reason further reduction in sampling frequency is not recommended.

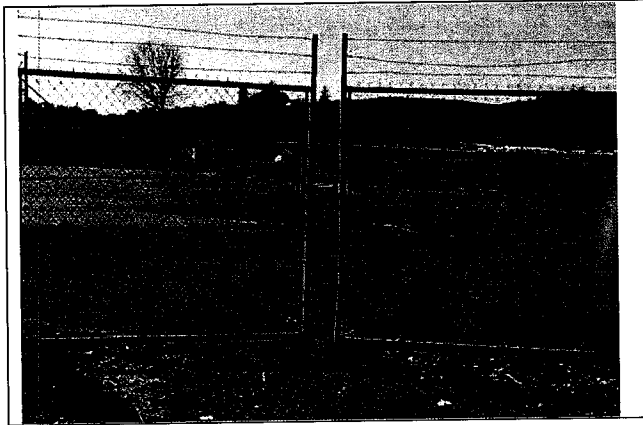
Photo 1. Front gate; closed but unlocked.

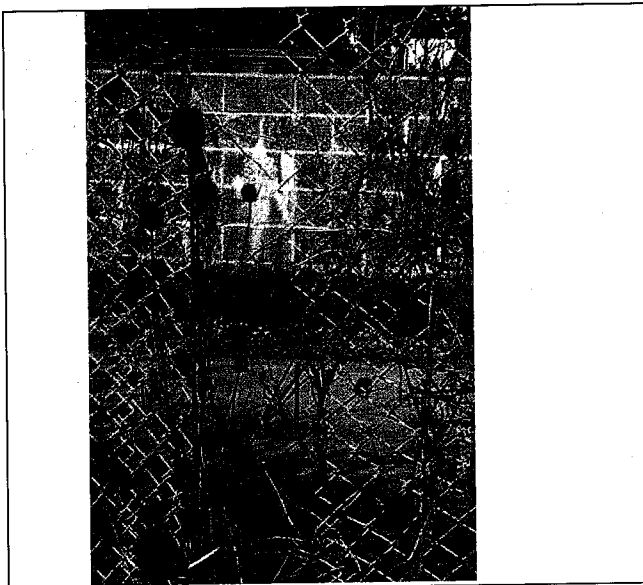
Photo 5. Hole #1 in fence beside Donovan Rd.

1. **Fencing damaged** ☐ Location shown on site map ☐ Gates secured ☐ N/A  
 Remarks An aluminum chain-link fence topped by three rows of barbed wire surrounds the MGM Brakes property. Two breaks in the fence large enough for human entry and egress were observed along the northern boundary; otherwise the fence was intact and in good condition. The two remaining wells are off the MGM property and are not within the fenced area.

The breaches in the MGM Brakes property fencing have been repaired since the time of the site inspection. There are no known Site issues that, either currently or in the future, prevent the remedial actions from being protective.

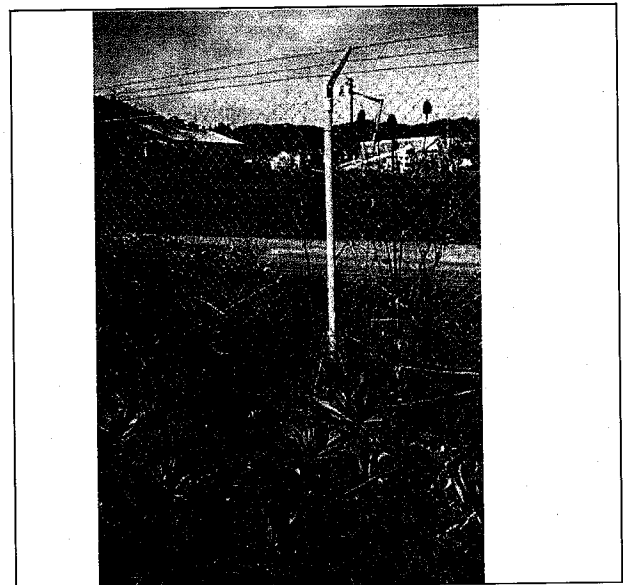
Photo 6. Hole #2 in fence beside Donovan Rd.

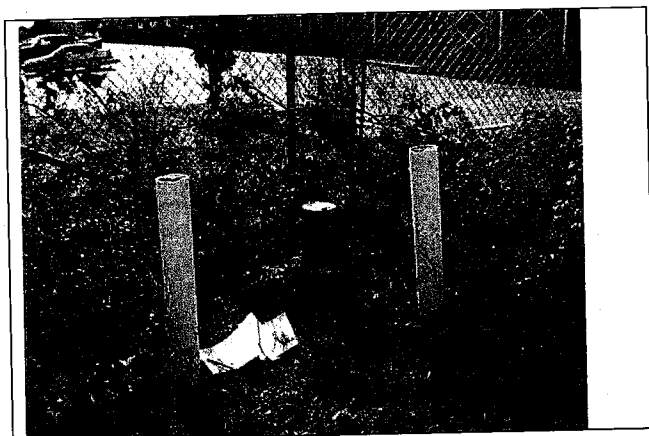
The lone deficiency noted for well B50 was the inability of its outer protective casing to prevent rainwater from collecting around the opening to the inner casing. When the sampling technician unlocks and uncaps the inner well casing for sampling, rainwater will likely enter the well casing and mix with the formation water to be purged and sampled. The expandable cap on B73, although locked, was able to be removed during the site inspection by a slight pull of the cap. This may be rectified in the future by simply expanding the cap to fit tighter in the well casing prior to securing the padlock to the cap.

Photo 9. Monitoring well B50 (TCE > 5 µg/l).
